**Report- Rander Gamtal**  
**GIS Based Mapping of**  
**Living Heritage of Surat**  
**for**  
**Improved Heritage**  
**Management in Surat**

**Surat Municipal Corporation**

**Urban Management Centre**

**March 2009**

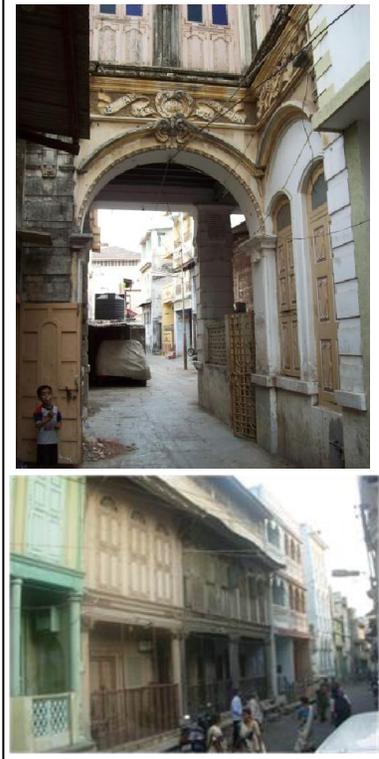
Figure 4: View of streets in Rander

Besides the elaborate monumental buildings the morphology and architecture of the closely packed residential units form a distinct historic precinct, which is rich in character. For any conservation intervention it is essential to list all structures in Rander which are responsible in creating the historic matrix.

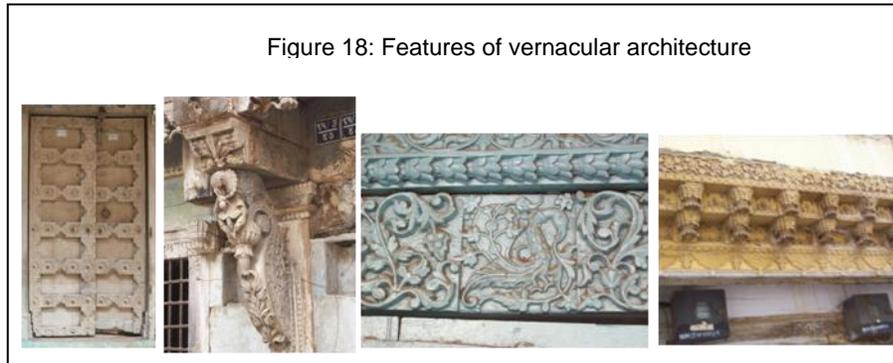
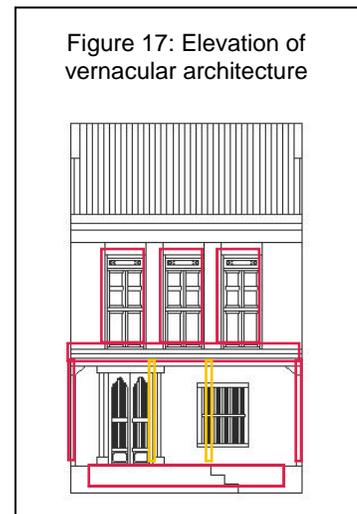
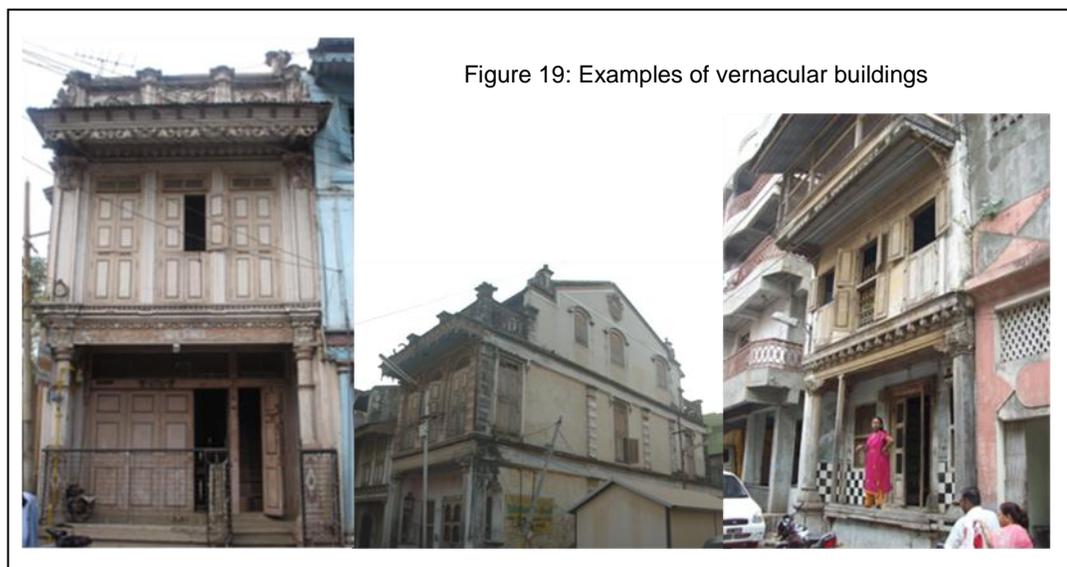
In this language there is a profuse use of wood in facade and structure. The structure is a composite structure in wood and brick and lime as the bonding material.

The wooden beam flooring is reflected in the facade in the form of a broad wooden architrave. It sometimes has large brackets and overhanging eaves.

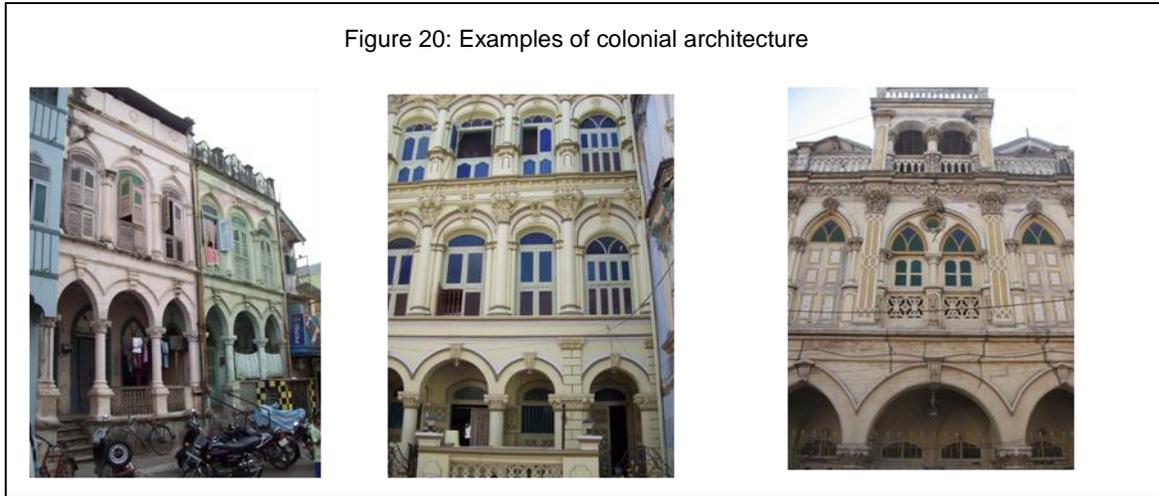
Figure 20: Examples of colonial architecture

The colonial influences are characterized by the semicircular openings on first floor, round columns on ground floor “*otla*” and a simpler architrave. There is no variation in plan, though the facade could be divided into four bays. The system of construction is similar to the vernacular, except in large buildings some wooden members may be replaced by metal. A truss would carry the sloping tile roof.

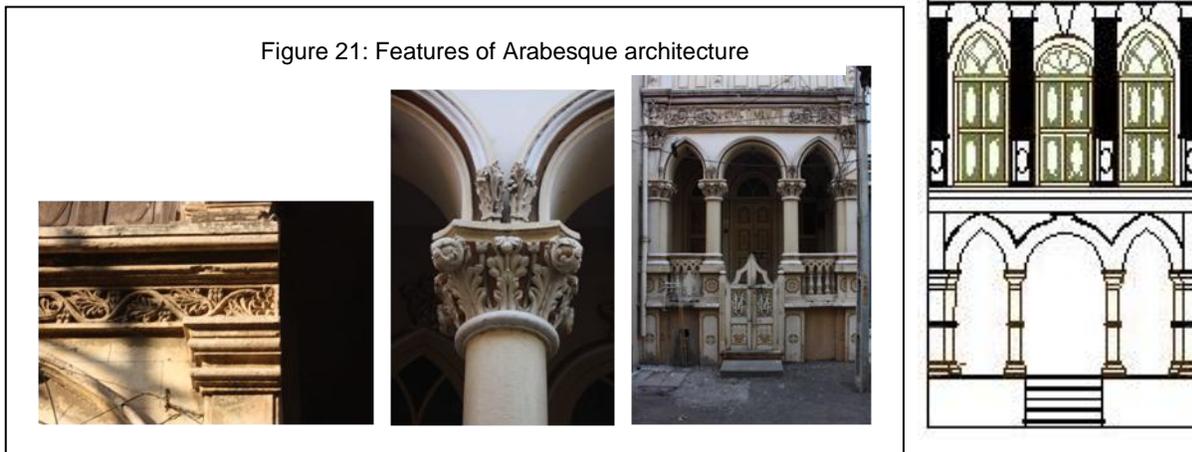
Figure 21: Features of Arabesque architecture

Pointed arches, stained glass windows, cast iron railings typify this facade. Except for the openings, there is no use of wood in the building which is made completely in brick and lime. Though it follows the same plan form, its plinth is taller and so are the floors.

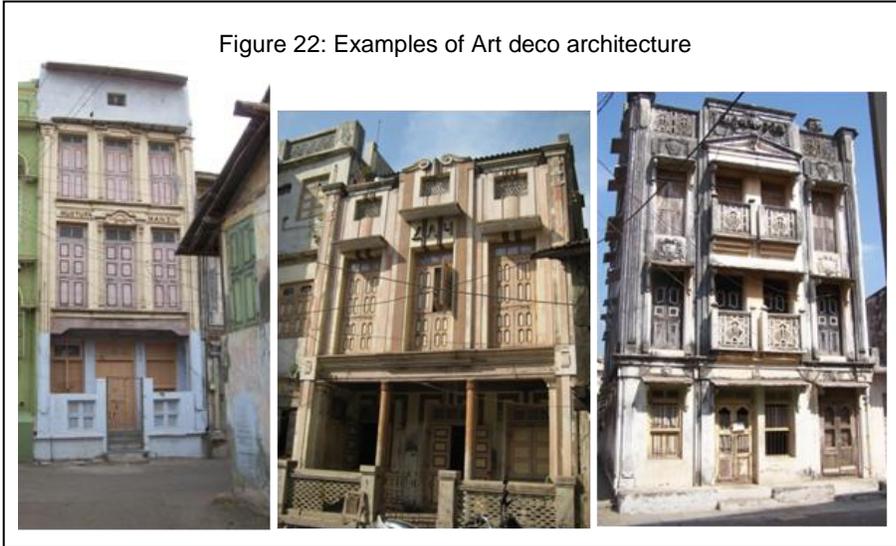
Figure 22: Examples of Art deco architecture

This continues to use the facade divisions of the traditional buildings even though the building materials have changes to brick and concrete and there might not be structurally a need to retain those divisions. But by doing so sets an example of being contemporary but contextual.

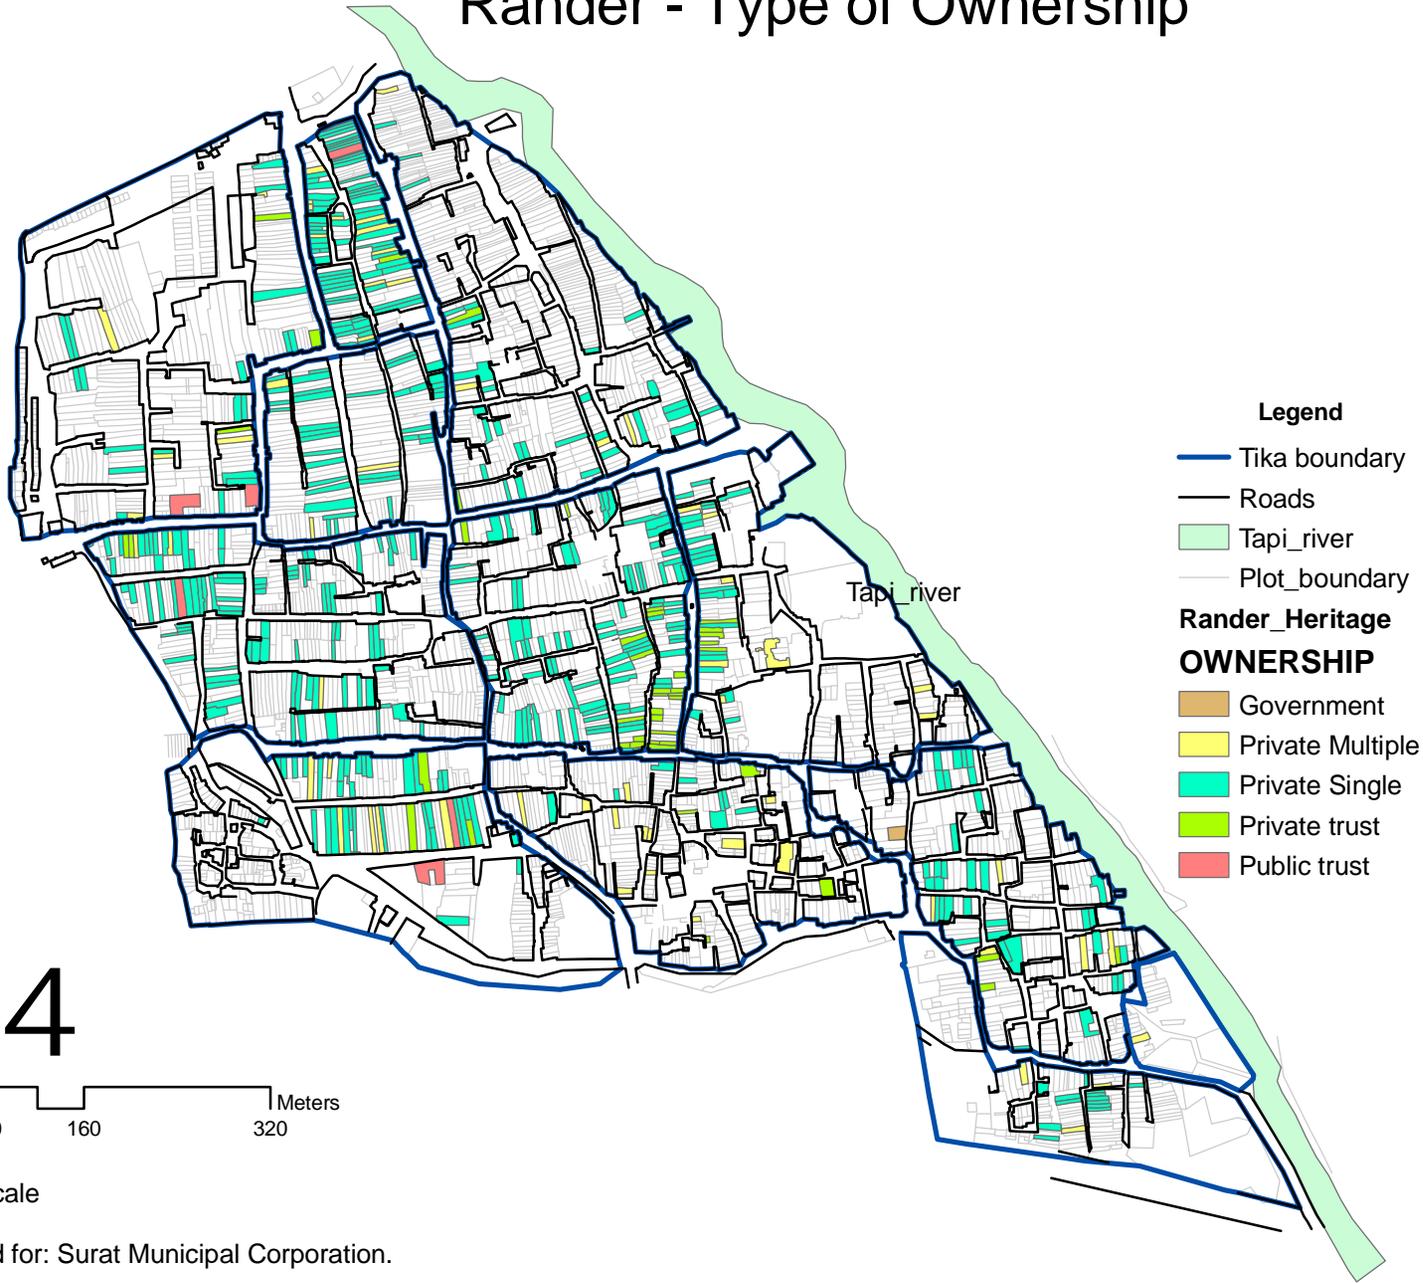
# Rander - Type of Ownership

From the survey, it is found that almost 90% of the heritage buildings are under private ownership. 78% of the total properties surveyed have single ownership where as only 12% are under multiple ownership. Due to poor economic conditions of the owners and lack of awareness and government fiscal supports, most of these buildings are not maintained properly. 9% of the total houses are under private trusts which include Jain trusts, Swaminarayan trust and Muslim trusts.

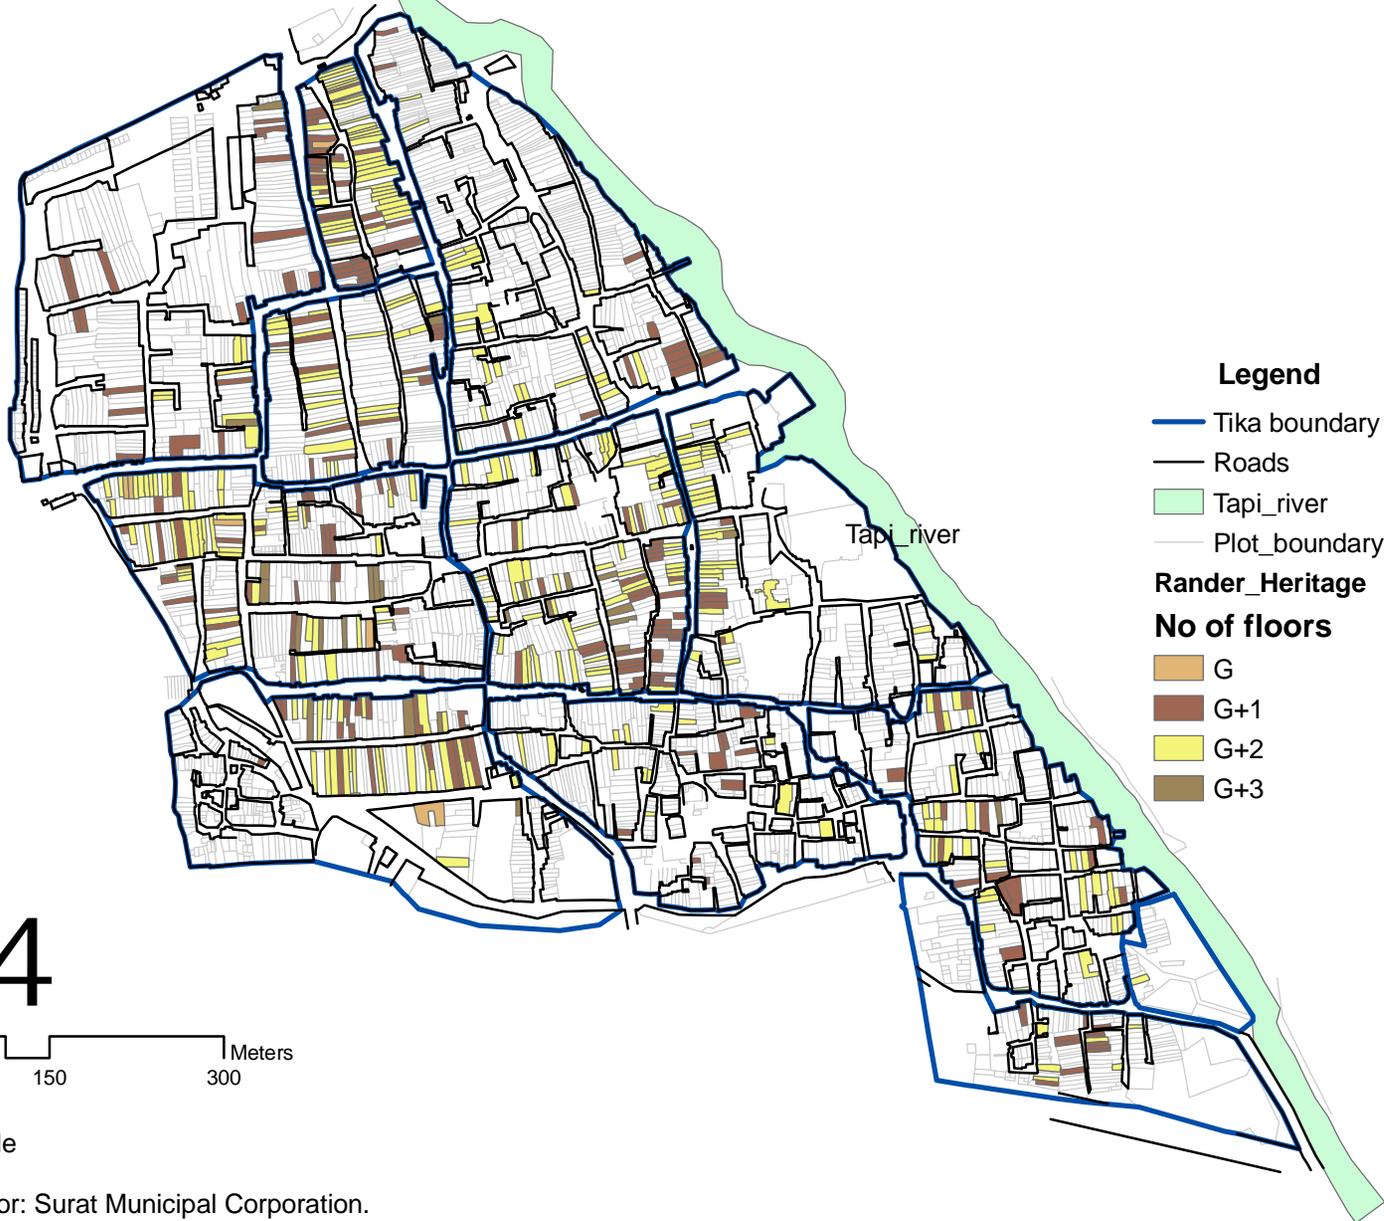
# Rander - No of Floors map

From the survey it is found that most of the buildings are of G+1 and G+2 structures constituting 40% and 54% respectively. Maximum numbers of floors found in Rander are upto G+3 only, which also includes the attic. Unlike the central zone, houses in Rander do not have a basement. The survey results showed that only 1% of the total houses have basement.

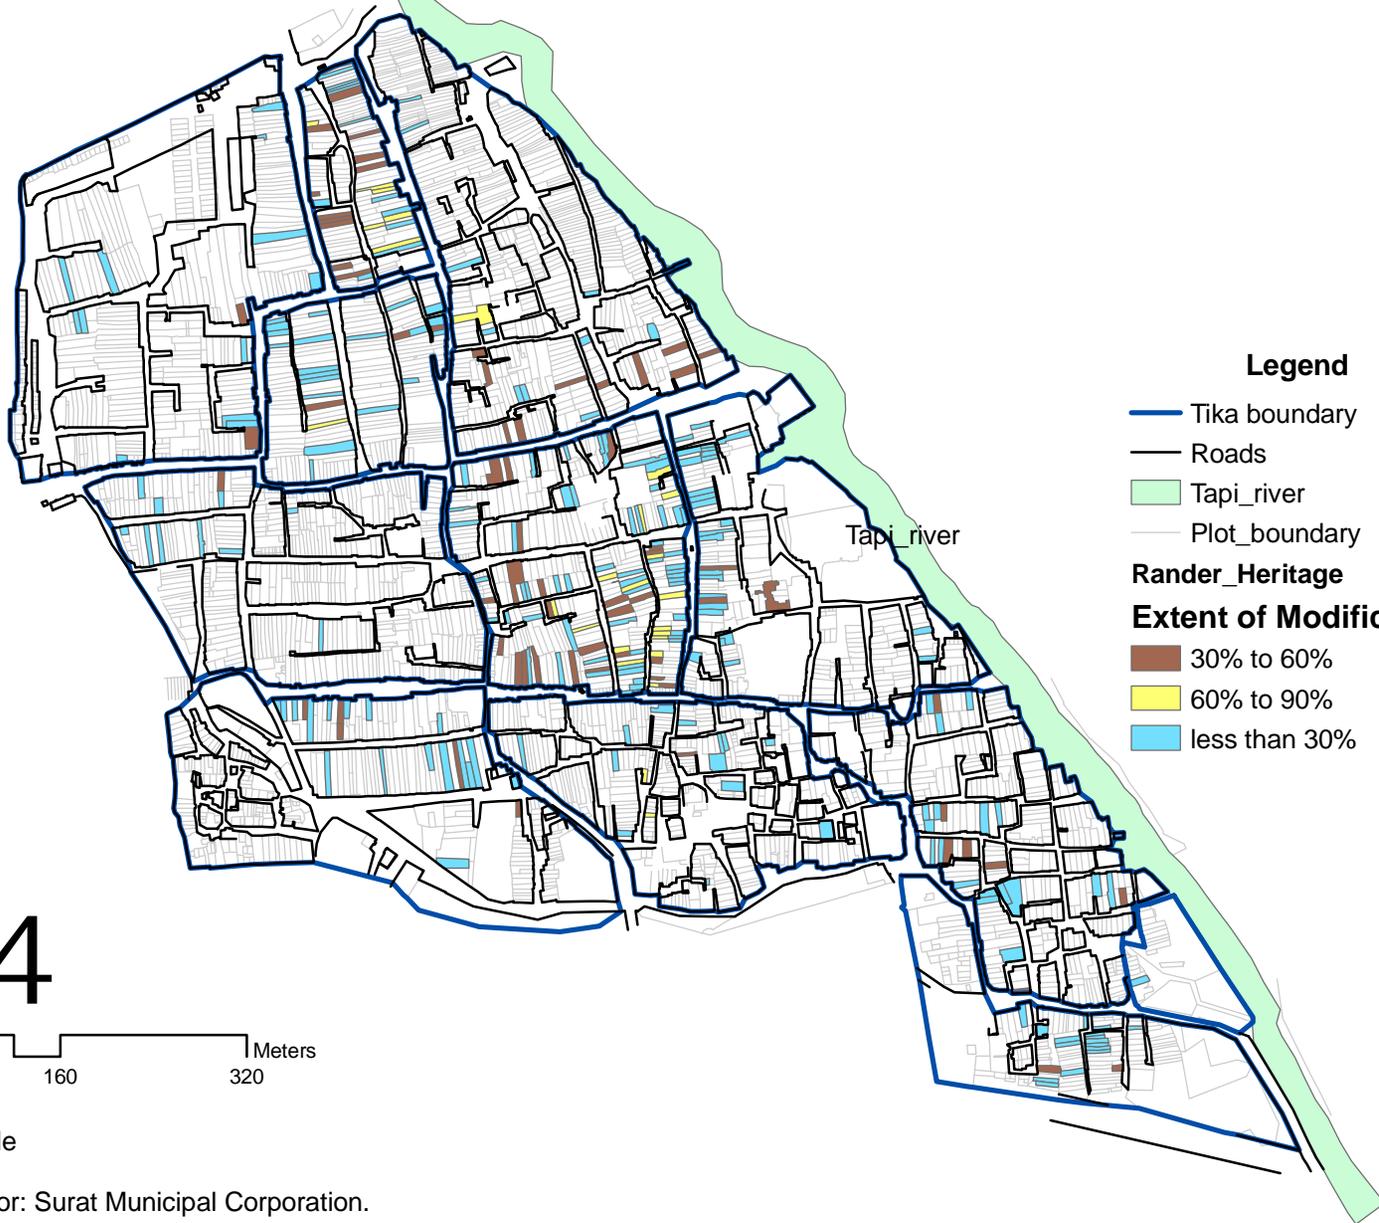
# Rander - Extent of modification

From the survey it is evident that despite rapid urbanization, Rander Gamtal has managed to retain its rich heritage. Only 9% of the houses have been modified more than 60%, where as 69% houses are modified less than 30%. The main reasons for modification have been aesthetics and comfort (37% and 34% respectively), which include modification in floorings, walls, openings etc. Only 26% are modified due to structural failure and damage of the building caused by the termites, floods and earthquake. In many houses, the wooden beams have been replaced but iron girders or beams. Even though most of the houses are not structurally stable, the percentage of structural modification is less, which may be due to the poor financial condition of the residents and lack of willingness and awareness.

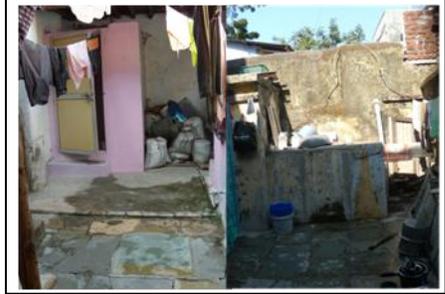
Figure 24: Location of vada and utility

The houses in Rander are mostly having vertical linear layout, which is thin and long, with *vada* is present at the end. The entry to the *vada* from house and from *vada* to infrastructure is same for all houses. The size of the *vada* can change according to the plot size or position of street outside, from where *vada* can also be accessed. Due to the presence of different cultures in Rander and as many houses are modified, about 36% of the houses have different plans which do not fall in any of the category identified. The plans with two rooms, stairs at the first room and a *vada* before toilet (P1) and three rooms, stairs at the first room and *vada* beside toilet (P2) is the next common plan found in Rander, which is almost 48% of the total houses surveyed. Only 9% of the houses have two rooms, stairs at the second room and *vada* before the utility

room (P3). 3% houses have three rooms extended, stairs in the second room and *vada* beside toilet (P5) and 2% have two rooms, stairs in the second room and *vada* beside utility (P4). Only 2% of the houses have a horizontal linear arrangement of rooms (P6).

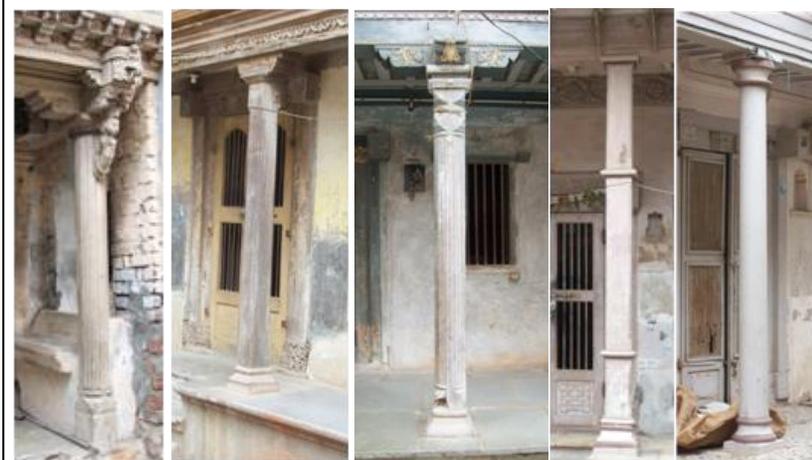
Figure 26: Examples of Columns

From the survey it is found that, particular column cannot be attributed to one particular architectural style. We often see it being used in different architectural styles in diff time periods. 41% of houses have sleek and rectangular (C4) columns. 31% columns do not fall in the defined categories, which may be due to the modifications done in the columns. 19% of the houses have wooden cylindrical (C1) columns, which are mostly found in vernacular houses. Only 4% have C5, 3% have C2 and 2% of the houses have C3 type of columns.

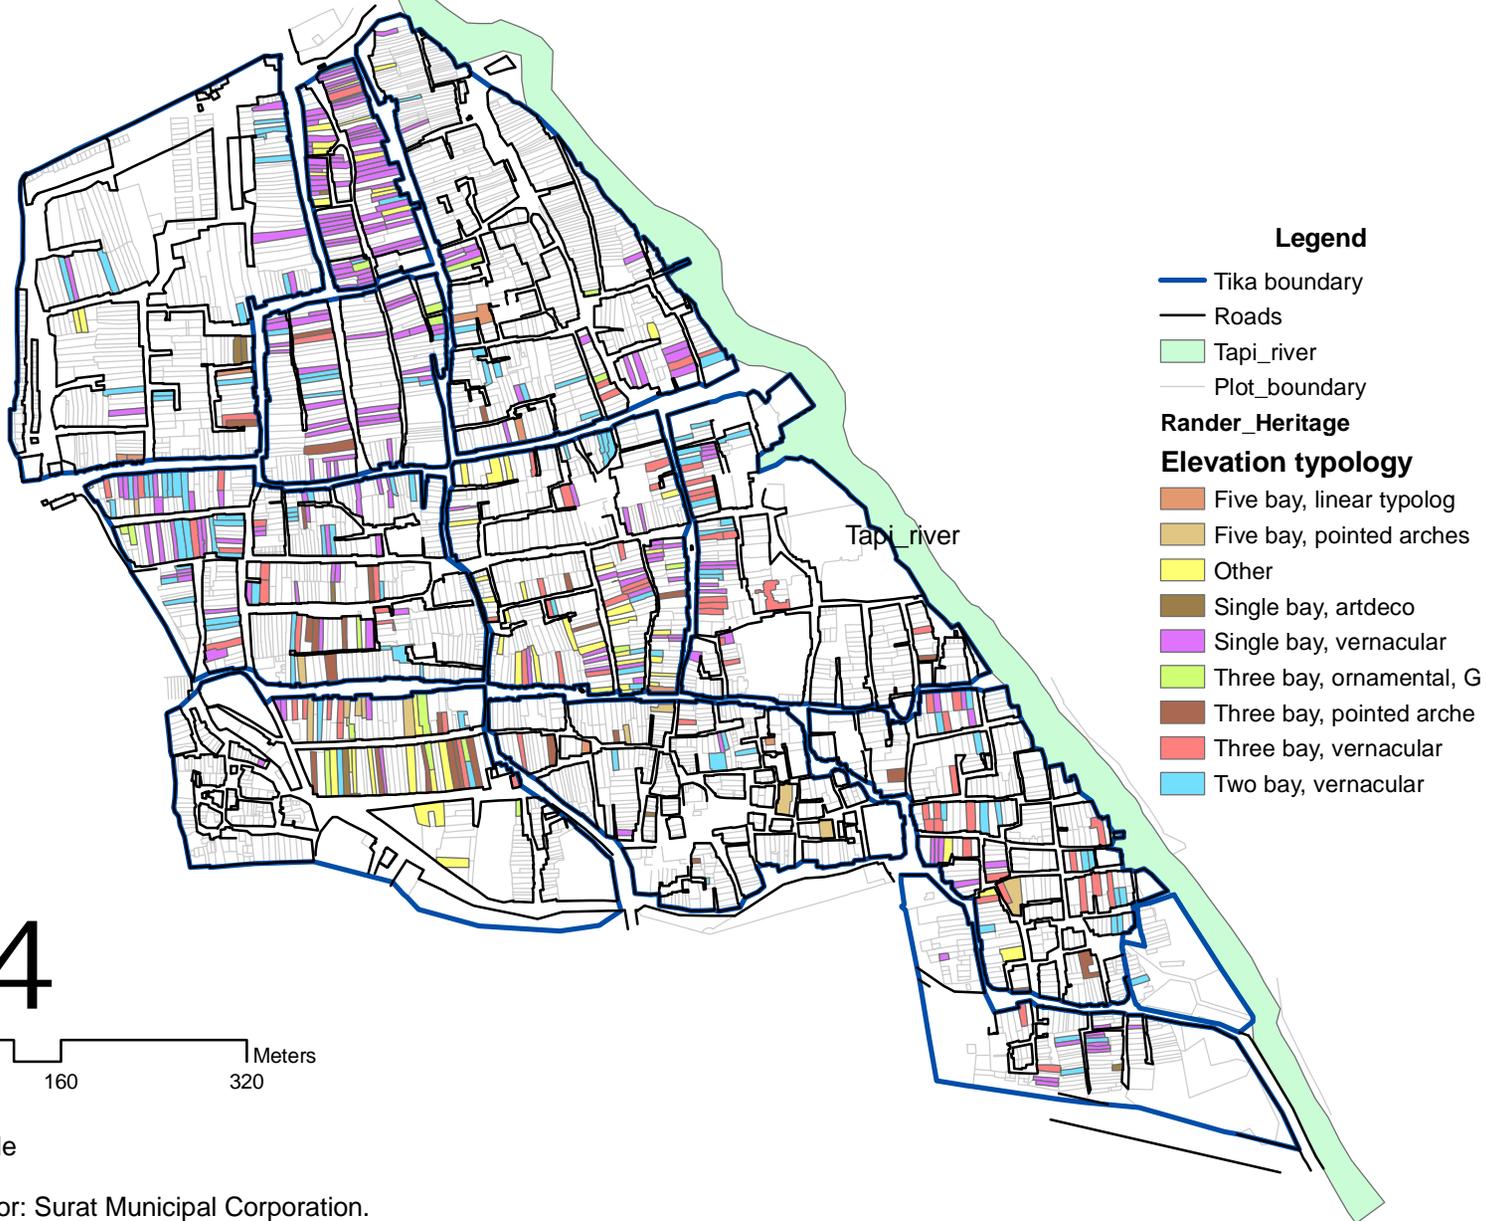
# Rander - Elevation typology

In elevation it is found that 75% of the houses have typical vernacular architecture with single bay (E1) as 39%, two bays (E2) as 21% and three bays (E3) as 15%. 5% of the houses have three bay (E4) and five bay (E5), pointed arches. 2% are three bays ornamental houses in which 1% has G+1 floor (E7) and 2% have G+2 floors (E8). Only 1% of the houses are typical art-deco with single bay (E6). 2% of the Houses have five bays, linear typology (as in P6), (E9) 14% of the houses do not fall in any categories identified.

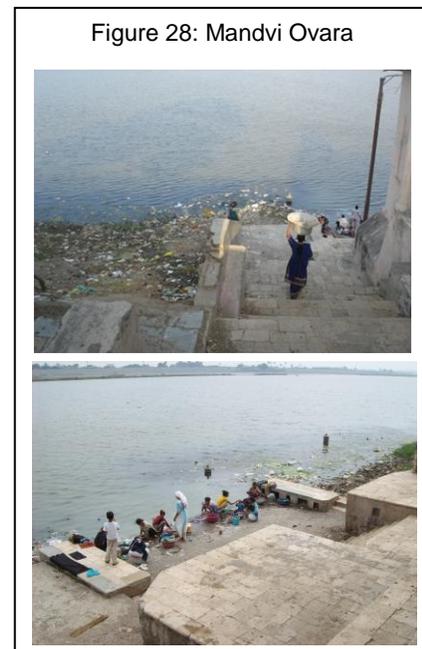
Mandavi *ovara* is the only *ovara* present in Rander, which was in use before Surat was developed as port. This was the biggest *ovara*, with boats being anchored here. In past it was used as a harbor for the ships coming from various countries. Around the 9<sup>th</sup>-10<sup>th</sup> century the usage of Rander *ovaras* declined.<sup>8</sup>

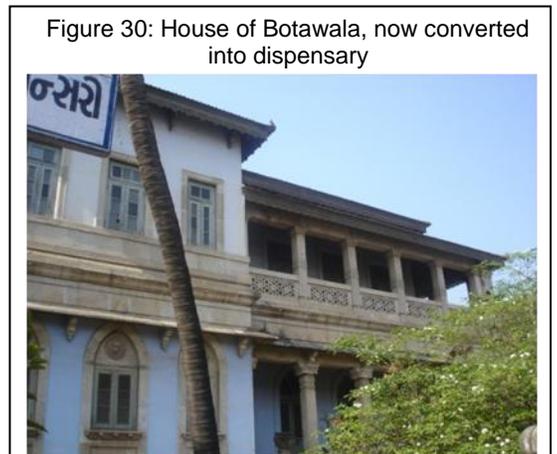
Figure 30: House of Botawala, now converted into dispensary

Botawala was one of the Vora businessmen who came to Rander for trading. In 1888, he donated Rs. 4 Lacs for provision of water and sanitation lines. After this, most of the houses were connected to water and sanitation lines and electricity connections were provided. It was the only village having electricity connections at that time. At present, the house of Botawala is being used as a public dispensary, by a trust, giving services in very subsidized rates.<sup>9</sup>

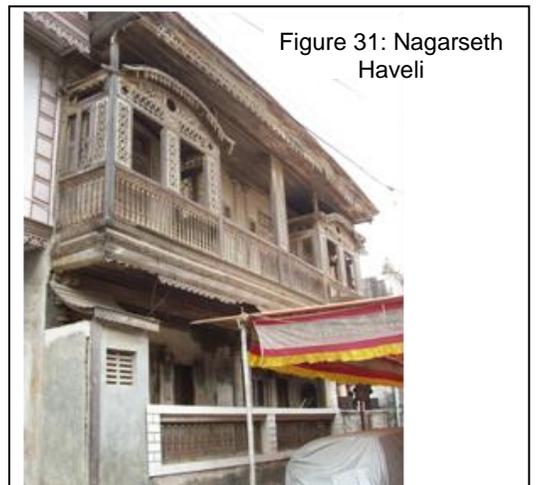
Figure 31: Nagarseth Haveli

Rander Nagarseth Haveli is one of the most prominent buildings in *Mota falyu*, *Kabutar Khana*. The nagarsheth belongs to Jain community, but typical vernacular features of Jain culture cannot be seen in the house. His *haveli* resonates the importance and influence of the Nagarsheth. The scale of this house is much larger than usual vernacular house.

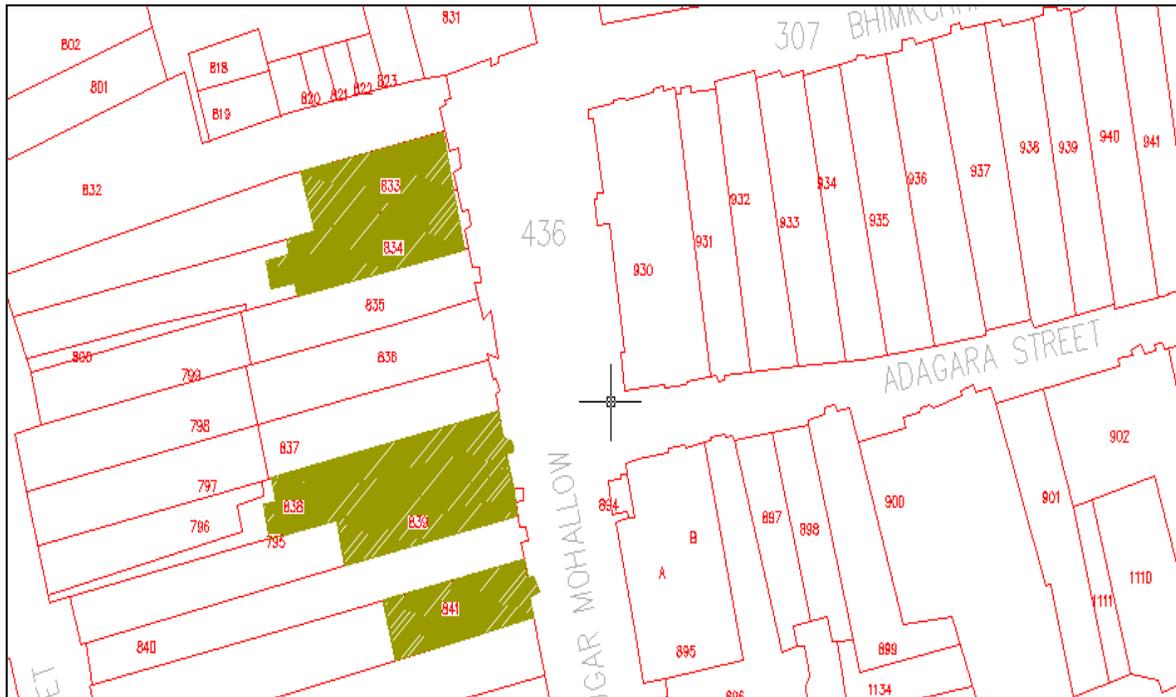
Specific number of survey forms and guiding maps are provided to the surveyor by the supervisor for the day. The guiding maps contain the location of all the building to be surveyed, it also contains plot boundaries, street names and the plot nos. The plot nos in the surveyor to the buildings to be surveyed for the day. The surveyor is expected to fill in the survey nos in the survey form cross referring the map and on the site.

Guiding maps for the surveyors, the buildings to be surveyed are hatch
